NJ Pilot Lake Studies: Cyanobacterial Toxin Monitoring

NJDEP Division of Water Monitoring & Standards
Bureau of Freshwater and Biological Monitoring

September 23, 2015

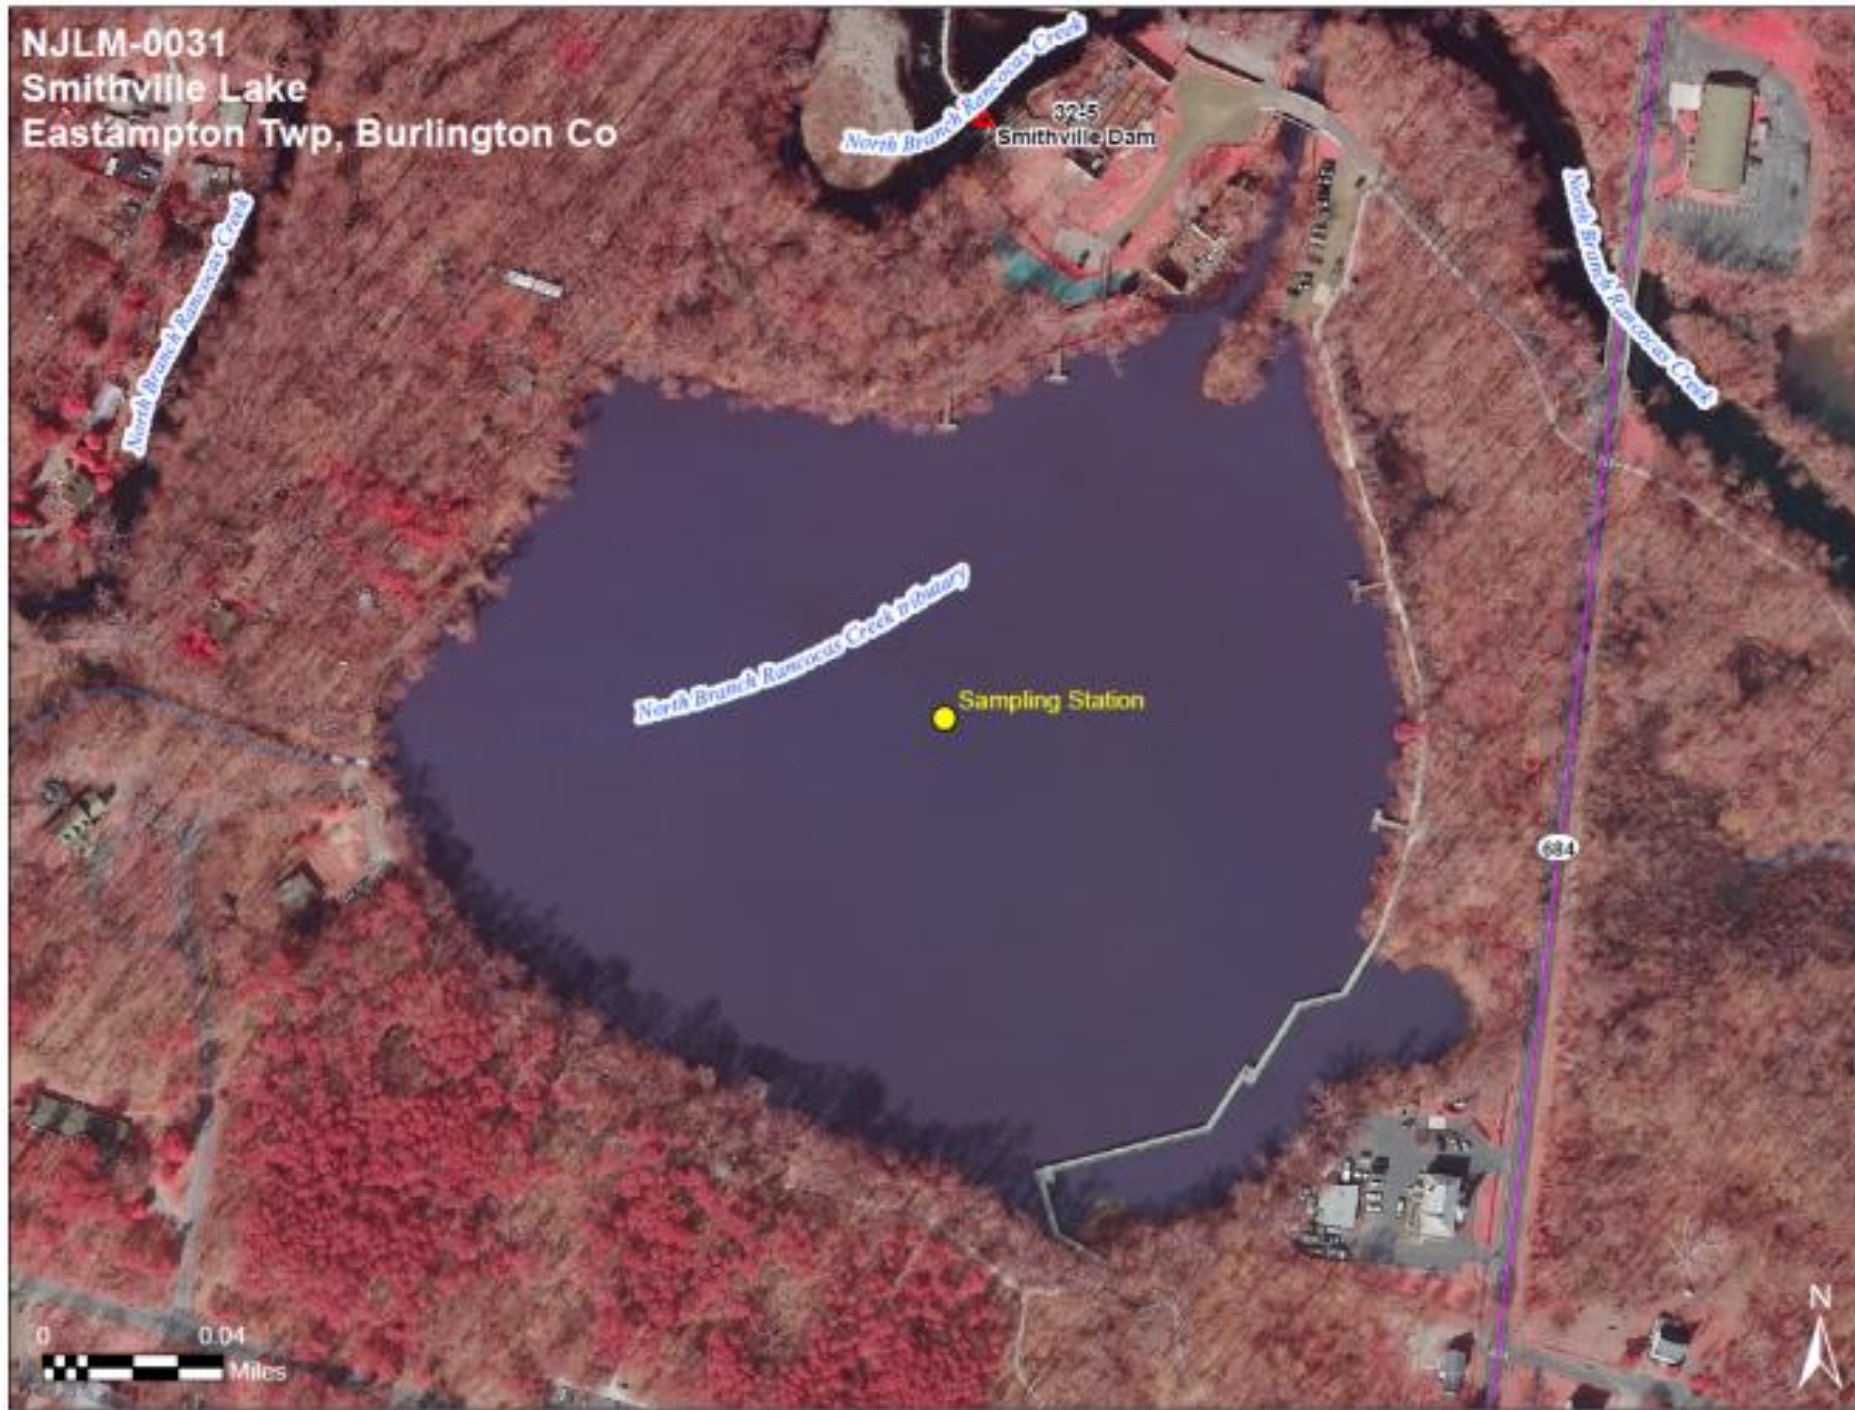
NJLM-0031
Smithville Lake
Eastampton Twp, Burlington Co

- Monitor weekly August – September
- Sample water column (1 meter)
- Sample surface where bloom is concentrated.
- Perform visual site assessments.

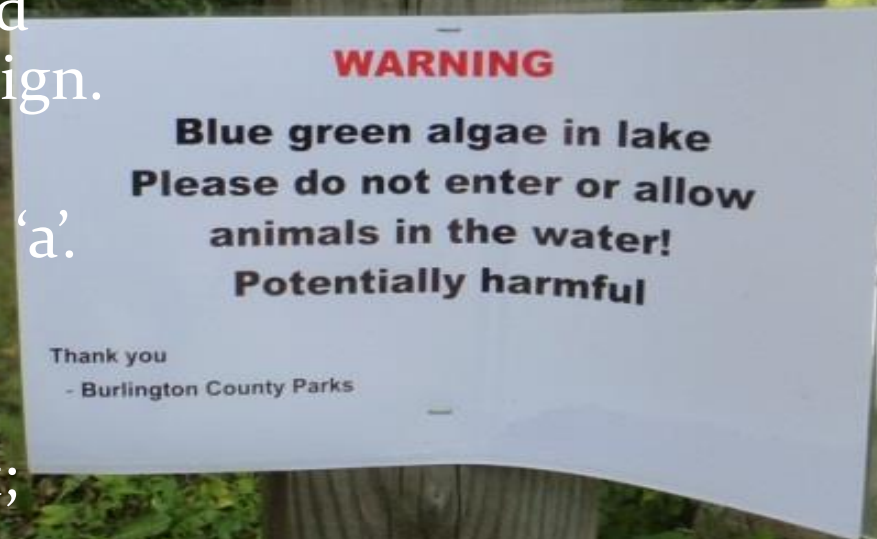
- July 2014 contacted by Rutgers Cooperative Extension of Burlington County
- Cooperative contacted County Park to post sign.
- BFBM sampled for microcystins and Chl 'a'.
- High Chl 'a' but low microcystin level.
- *Anabaena* sp. present; some *Anabaena* sp. produce anatoxin and not microcystin.

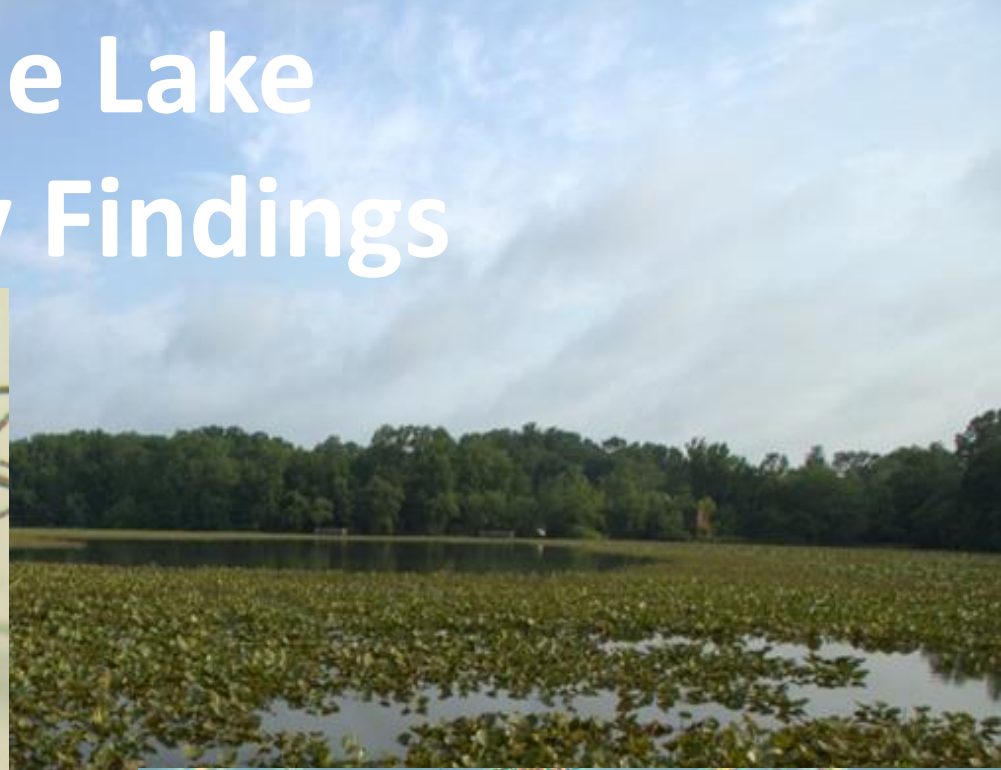
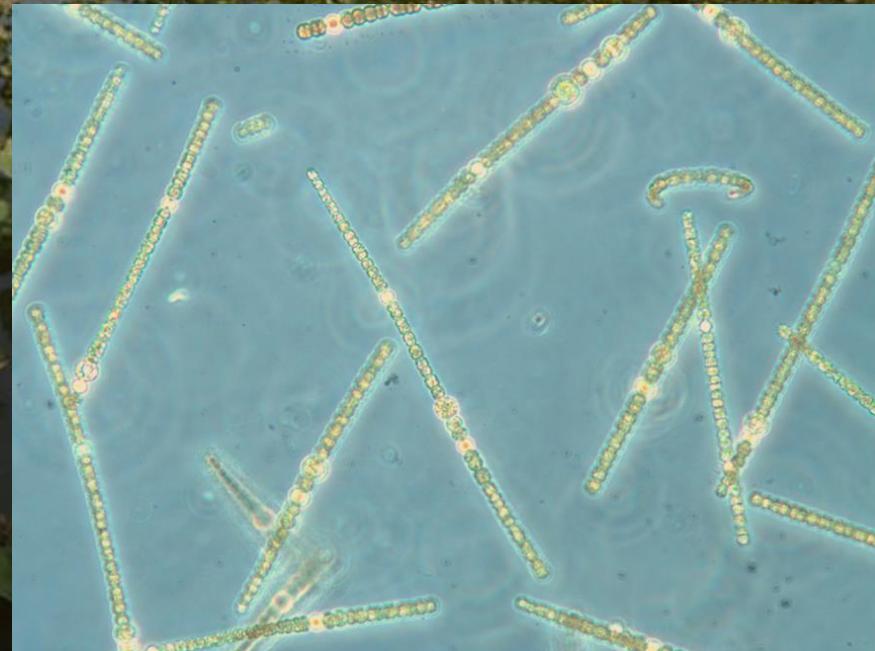
Anabaena sp. from Smithville
Lake.

- High Chlorophyll a concentrations in water column
 - Up to 185 $\mu\text{g/L}$
- *Anabaena* sp present
- Surface and Water Column
 - No microcystin strip test detection
 - Microcystin lab analysis just above detection
 - No anatoxin or cylindrospermopsin detected
- Nutrient results pending

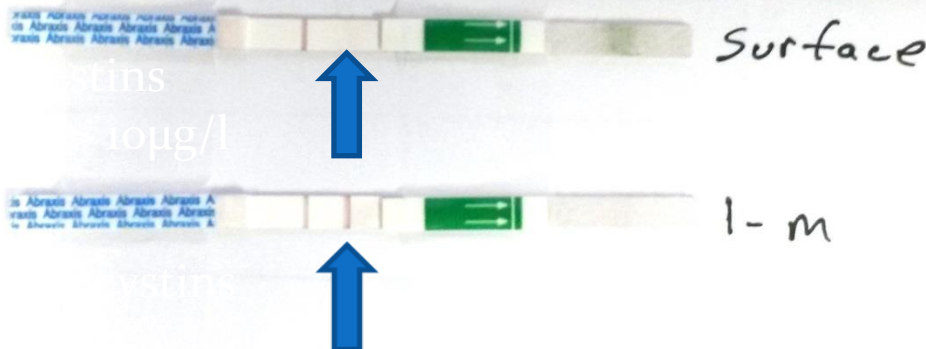
Hopkins Pond 9-08-2015

ELISA Lab
Microcystin Analysis

Surface – 11.58
µg/l

1-m – 0.36 µg/l
